Manhole Inspection Summary

Manhole # S33OO_019MH

Location Address: **2302 HOWARD ST**

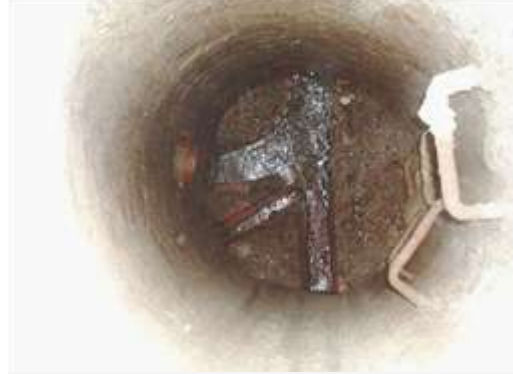
Top View

Corbel and Barrel infiltration. Corroded steps. Bench debris.

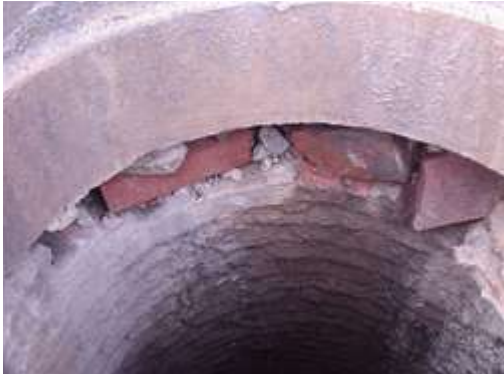
Defect

Frame leaks. Adjustment deterioration, loose brick, and infiltration. Corbel infiltration.

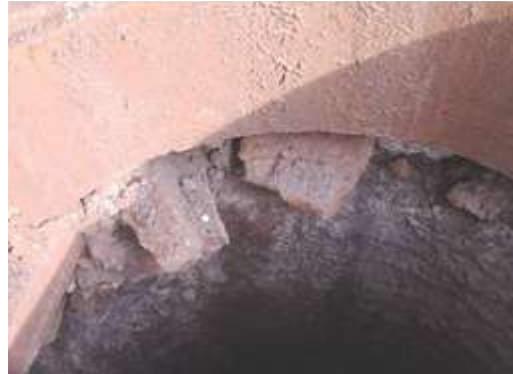
Defect

Frame leaks. Adjustment deterioration, loose brick and infiltration.

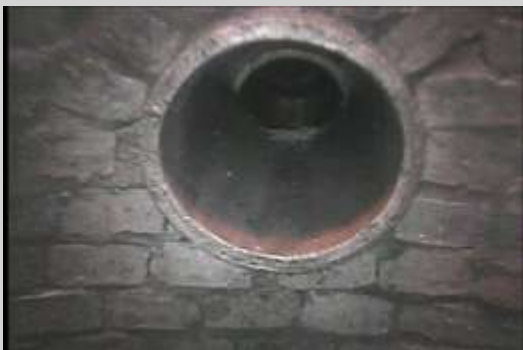
8 in. Circular Gravity Sewer

Deposits: ☐ None ☐ Mud ☐ Sludge ☐ Debris ☒ Grease

Silt Depth: **0** (in.) Deposits Extent: **Light**

Infiltration: **Evidence**

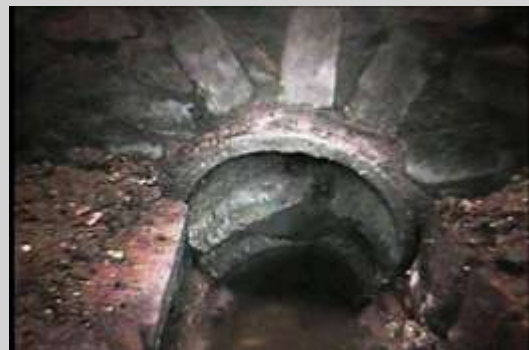
Drop In @ 9 O'Clock

Channel deterioration.
